**DEGRADAÇÃO SOCIOAMBIENTAL DO RIO BACANGA: UMA REVISÃO
BIBLIOGRÁFICA CRÍTICA SOBRE DESAFIOS E PERSPECTIVAS PARA A
NAVEGABILIDADE E GESTÃO HÍDRICA**

**SOCIO-ENVIRONMENTAL DEGRADATION OF THE BACANGA RIVER: A
CRITICAL LITERATURE REVIEW ON CHALLENGES AND PERSPECTIVES FOR
NAVIGABILITY AND WATER MANAGEMENT**

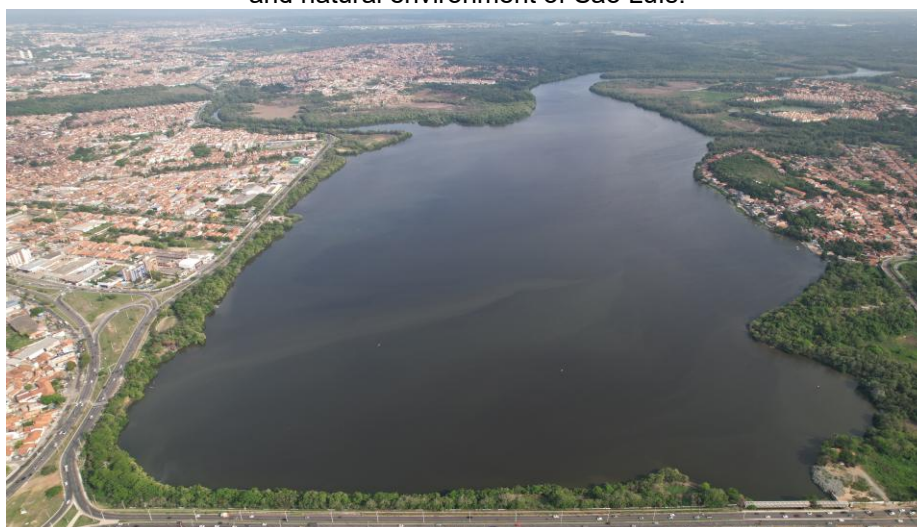
Figure 2. Panoramic aerial view of the Bacanga River, highlighting its integration with the urban and natural environment of São Luís.

Figure 2 presents a panoramic aerial view of the Bacanga River, allowing us to understand its extent and the direct relationship with neighborhoods in the northwest area, reinforcing its geographical and territorial relevance.

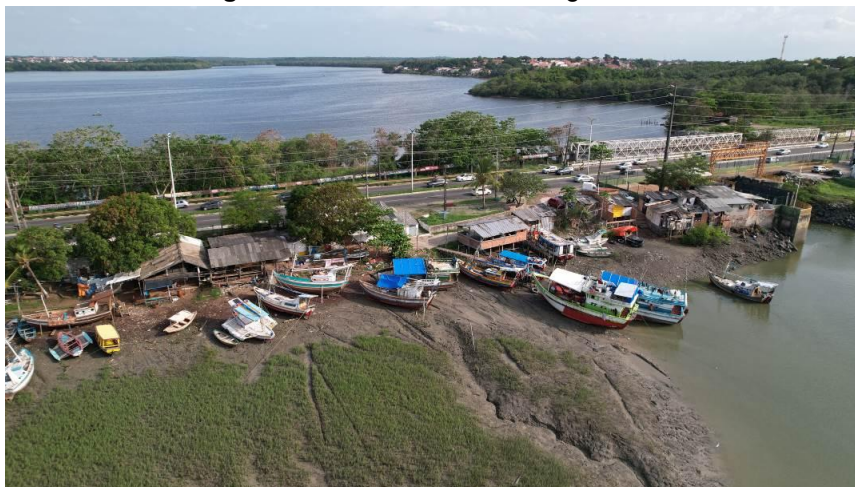
Figure 7. Vessels in the Bacanga River.

Figure 7 illustrates small vessels in the estuary used for community activities, highlighting the historical, cultural, touristic, and recreational potential of the river.
